AFWAL-TR-80-2126

HIGH TEMPERATURE STRAIN GAGE SYSTEM FOR APPLICATION TO TURBINE ENGINE COMPONENTS

Technology Programs and Performance Technology Department
Aircraft Engine Business Group
General Electric Company
Cincinnati, Ohio 45215

Technical Report AFWAL-TR-80-2126
Final Report for Period June 1976 - August 1980

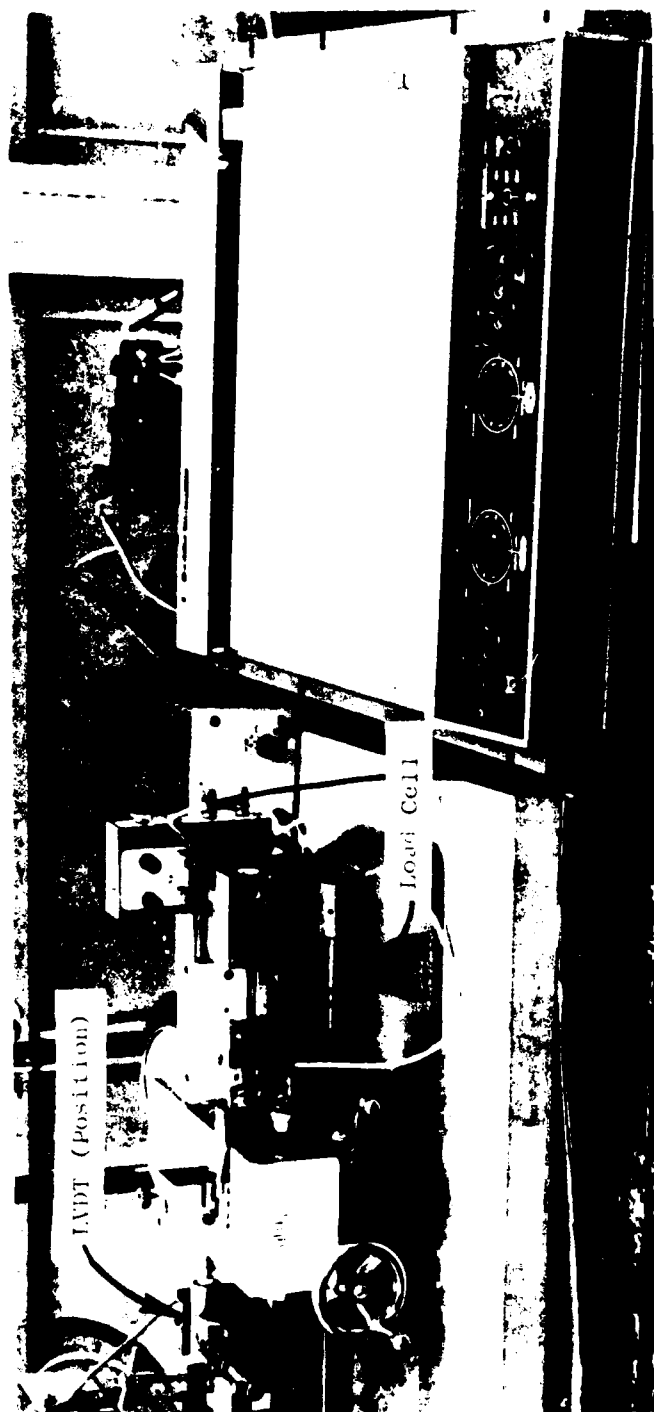
Figure 22. Fine Wire Test Machine.

A test was designed that involved pulling a 1/2-inch length of wire and recording the load in grams versus the elongation in mils on an X-Y recorder. Each end of the wire undergoing test was cemented to a Kapton tab. One tab was pinned to a small strain gaged cantilever beam that provided a calibrated signal of load to the recorder. The other Kapton tab was pinned to the carriage of a 4-inch lathe that traveled 2.4 mils/second. The motion of the carriage (elongation) was measured by a spring-loaded displacement transducer (LVDT) that provided X-axis input to the recorder. Elongation data must be corrected for load cell deflection versus load. This fine-wire test facility is shown in Figure 22. Typical failed test specimens are shown in Figure 23.

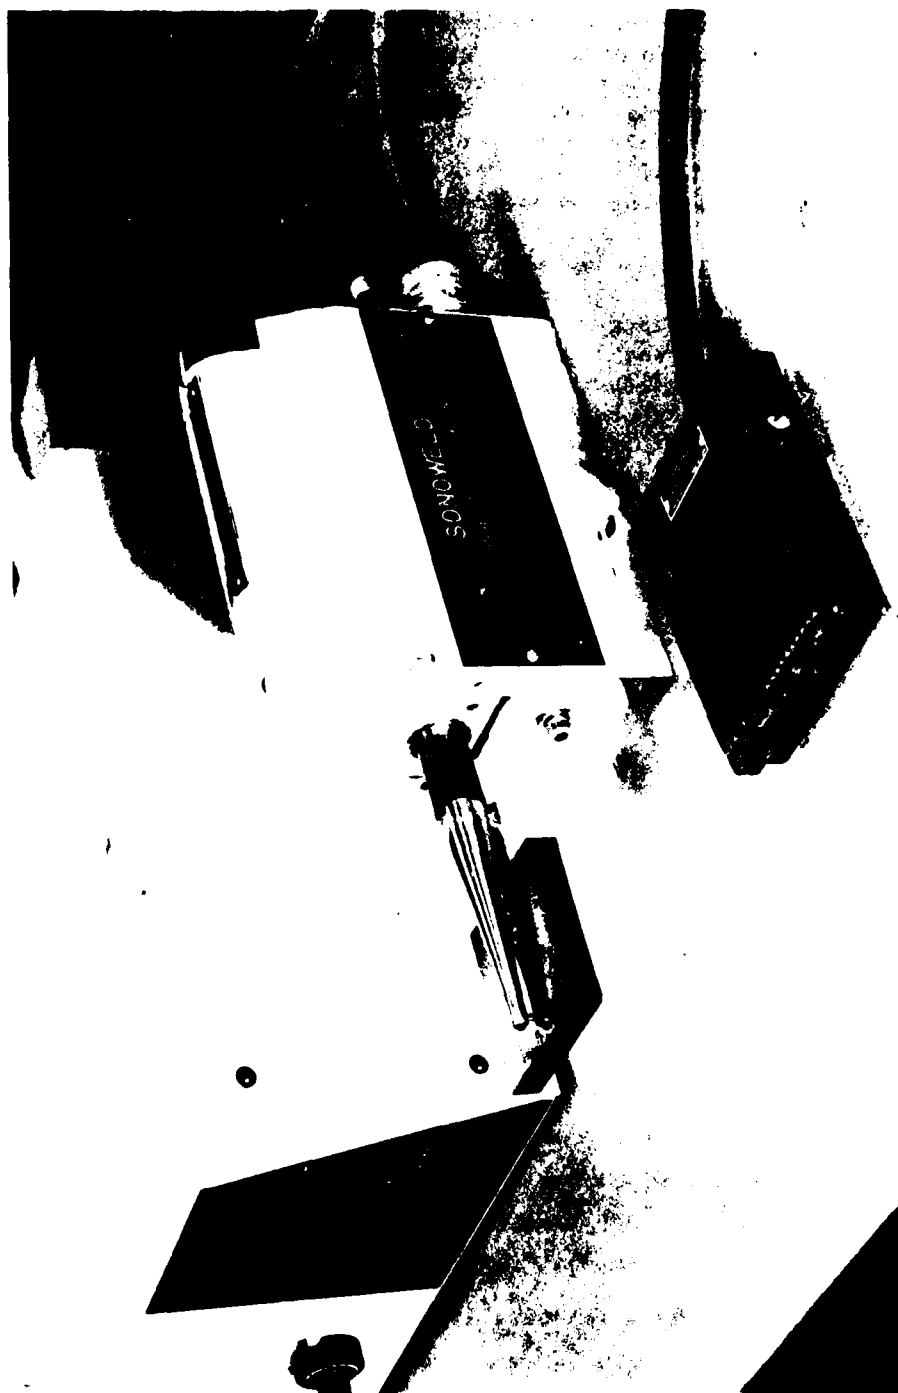
Figure 41. Sonobond Welder.

An ultrasonic welding system, Sonobond Model W-1040, Figure 41, was available for evaluation and process development. Original work, because it was a goal to remove the short piece of ribbon used to join the grid to the 0.003-inch diameter Chromel P lead, included bonding flattened grid wire to round and flattened specimens of Chromel P. Handling problems were encountered, however, because of inadequate fixturing. The process development continued using 0.015 inch x 0.001 inch Karma ribbon, as in the existing gage fabrication process. The Fine Wire Test Facility shown in Figure 22 was used to determine the strengths of the specimen bonds. Figure 42 shows the specimen design and the method of installation in the facility. By varying the force of the ultrasonic welder transducer arm, the power setting and time setting, and the number of discharges of the welder, bonds of the flattened wires to the ribbon were obtained that approached 80% of ultimate tensile loads of flattened wire. Cleaning the wire and ribbon surfaces with an acid solution of $\text{HNO}_3 + 5\text{HF} + 70\text{H}_2\text{O}$, which was neutralized before the weld was made, resulted in joints that nearly always exceeded the 80% UTL goal. All failures occurred in the wire next to the bond. Heat-treated Karma and Moleculoy weld

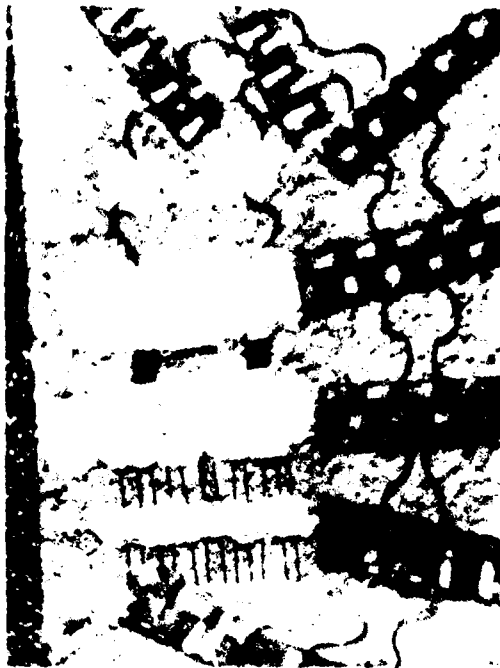
Figure 62. Molecule Gage Applications to F101 Rotor Blading After First Coat (Failure Sites Marked With "X").

Stage 3 and 8 blades were completed before it was determined that Pt-10Ni leads were superior to Chromel P (Test Number 57-77). These blades used the Chromel P leads on the airfoil. The Stage 9 blades were completed with Pt-10Ni leads. Figure 62 shows photographs of the gage applications after the first coats of alumina or Denex 2 cement have been applied. This figure identifies the failure sites determined by postmortem inspections. Figure 63 shows a typical completed splice of the convoluted leads to the Chromel Alumel leads that are routed through the spool of the compressor rotor to the slip ring or telemetry.

The failure of the Chromel P lead in the Stage 3 application was not surprising in light of previous experience. Stage 8 and 9 failures were in a grid filament that was either on or very near the Hi-C line. In Figure 62 the end loops of the gages appear to be in the fillet radius where the strain could be significantly higher than the average strain indicated by the gage.
